# Decommissioning of Offshore Pile Foundations: Current Practices and Future Research

**RAVE Workshop – Berlin**

Berlin, 13.03.2024

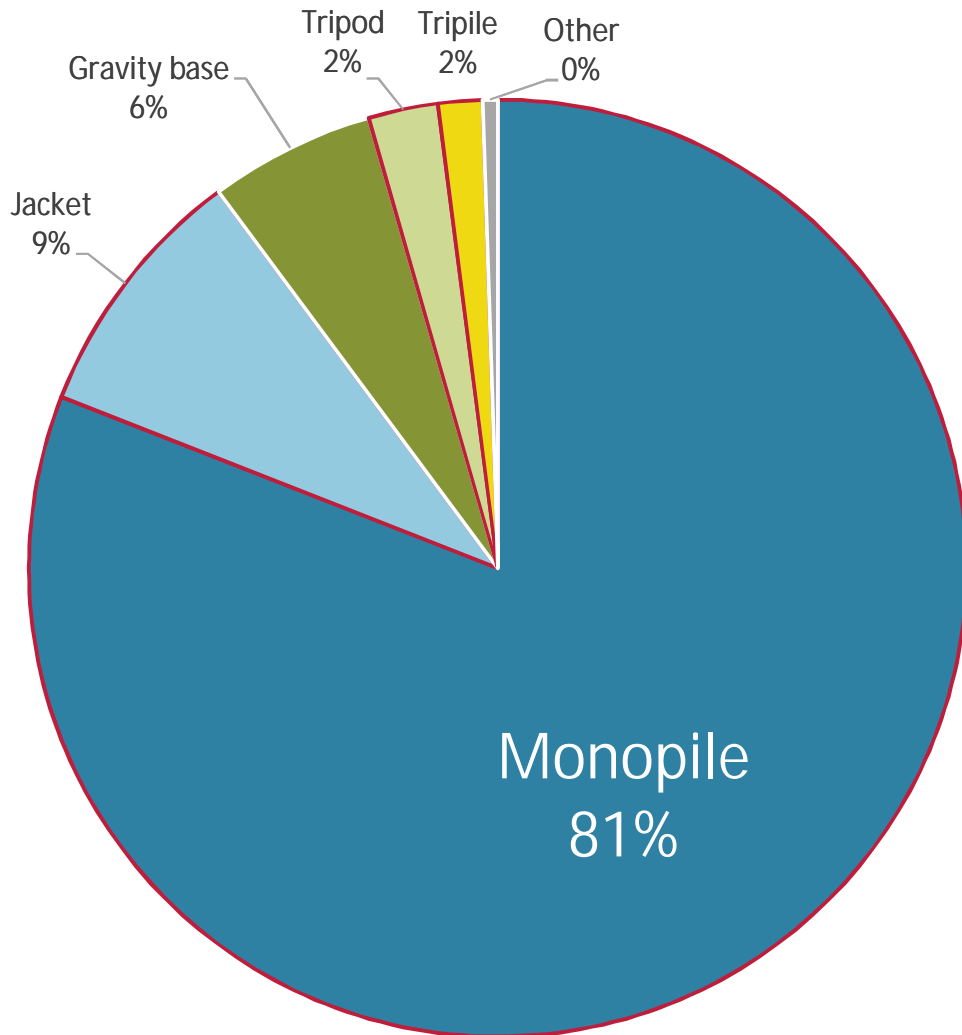
[WindEurope, 2019]

- Pile foundations → 94%

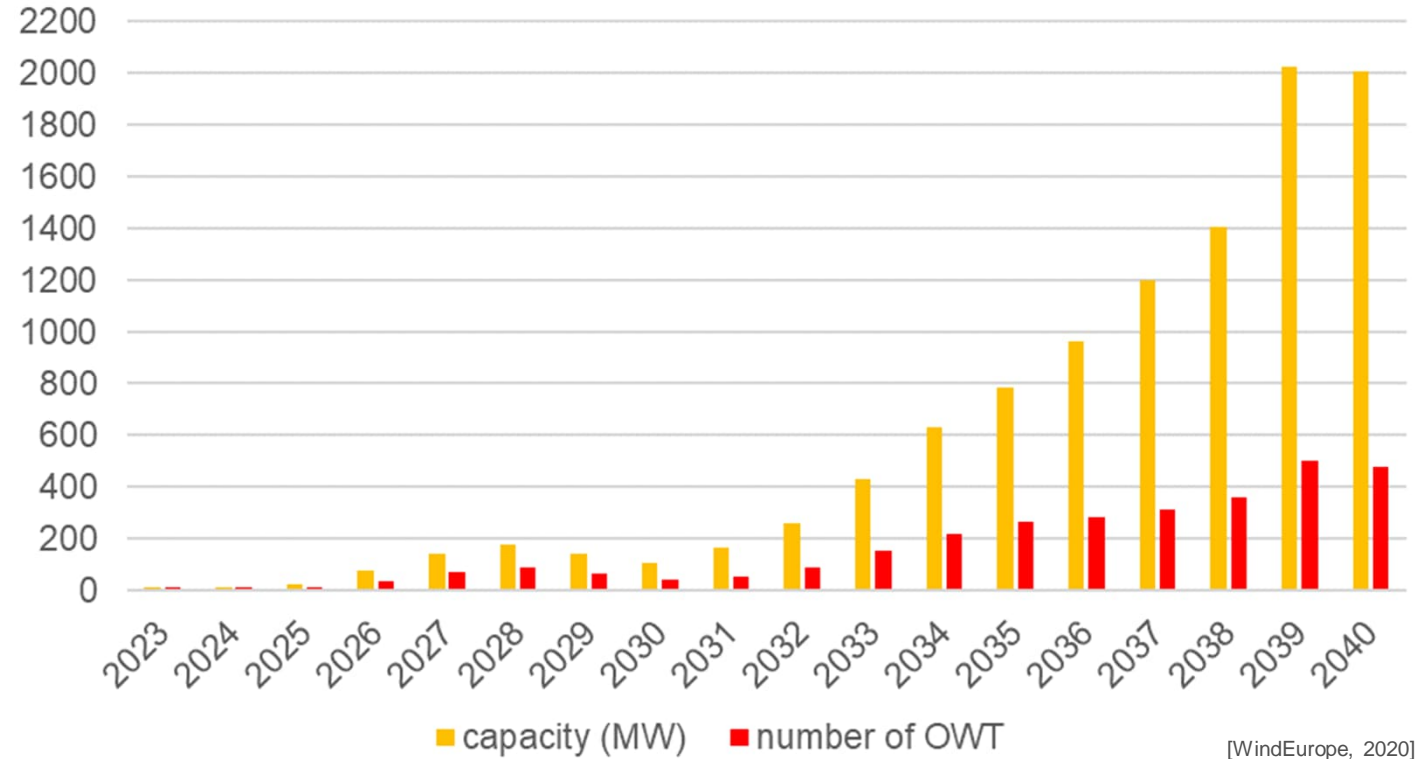
[WindEurope, 2020]

Predicted annual decommissioning of OWT

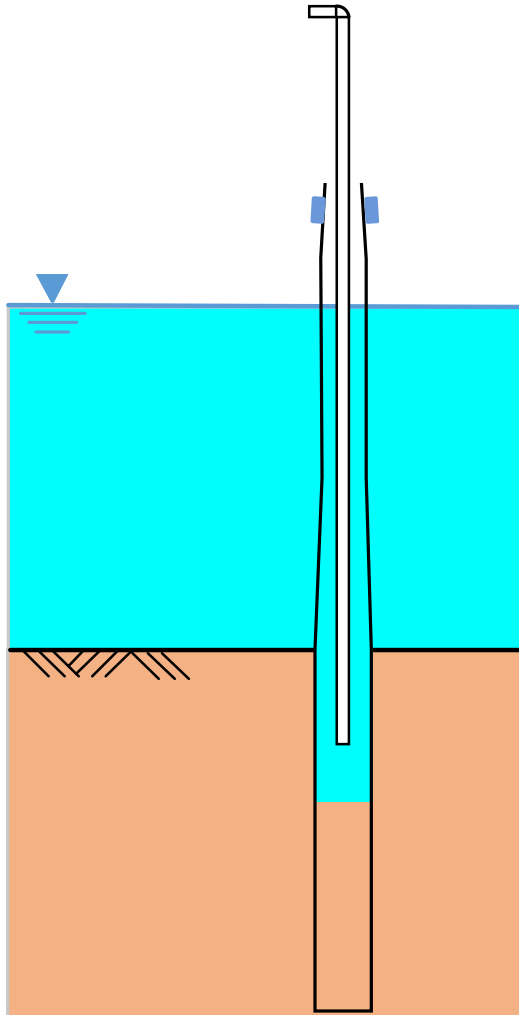
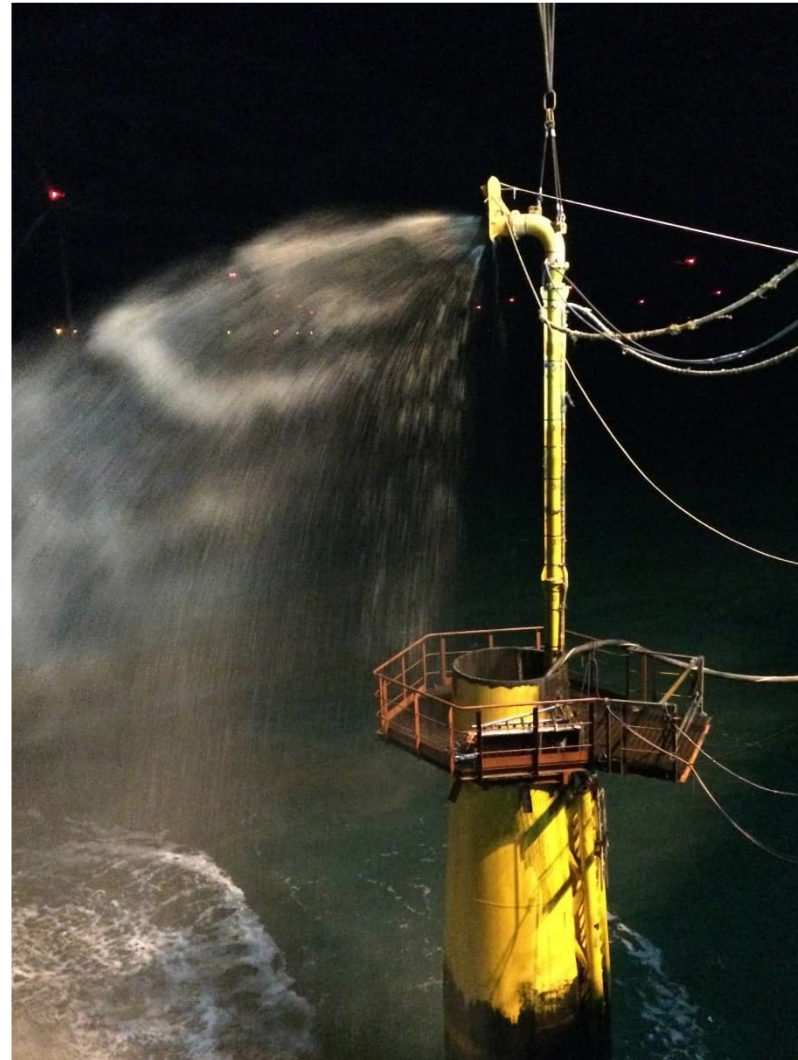
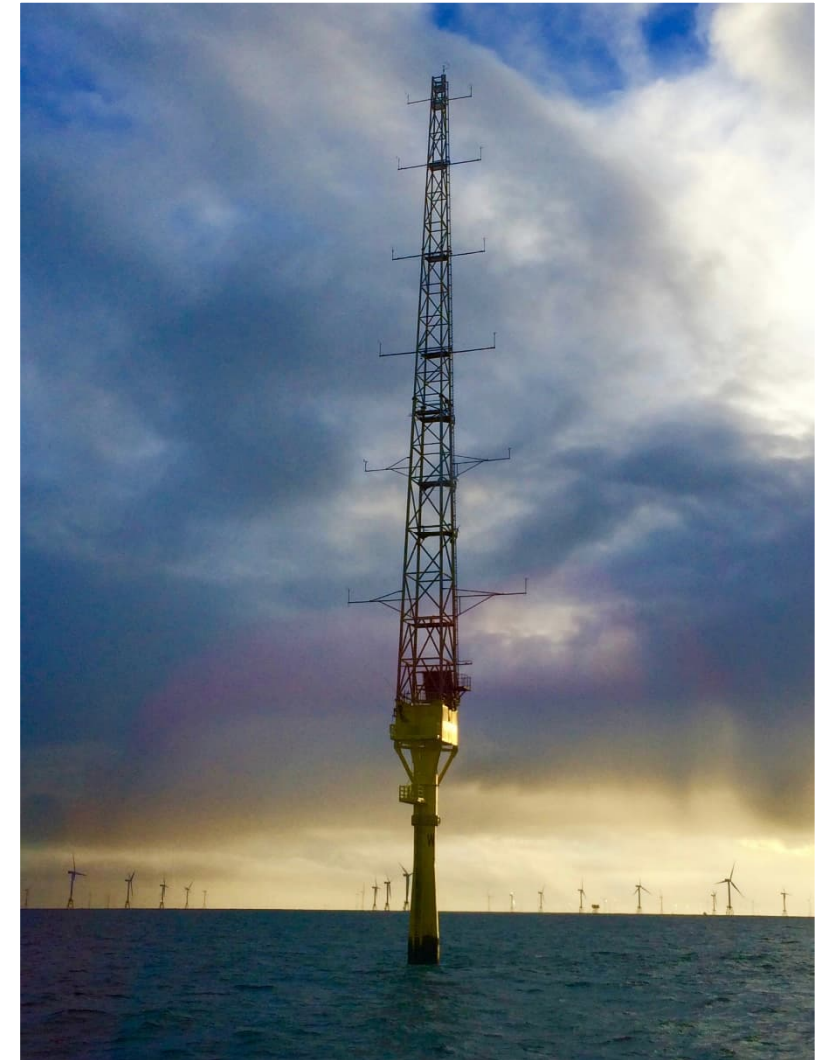
# Current practice – monopile decommissioning metmast Amrumbank West

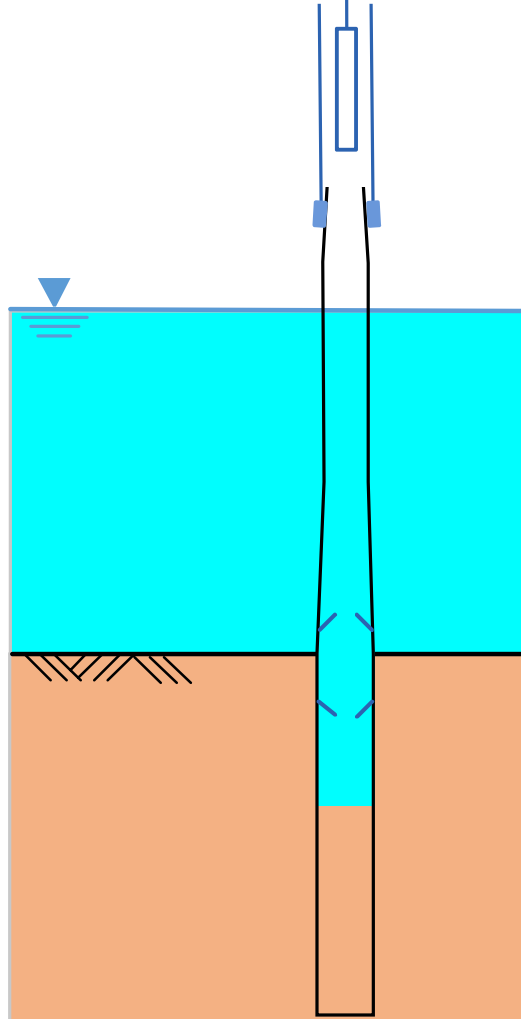
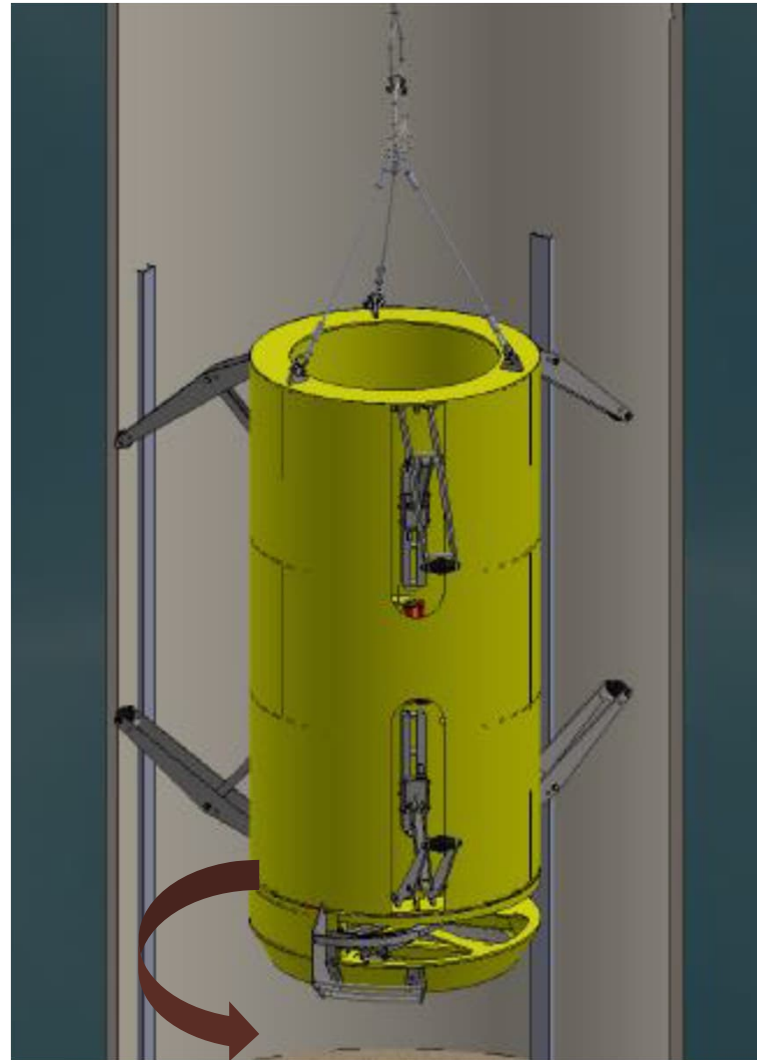
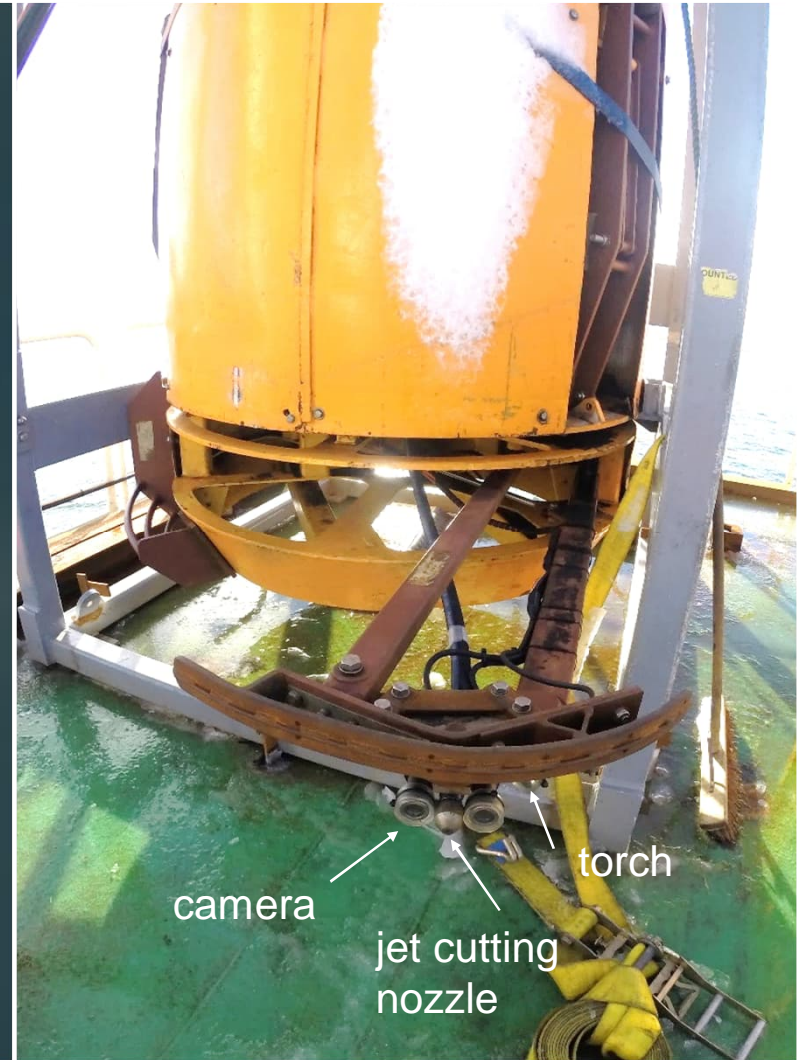
# Jet-Cutting

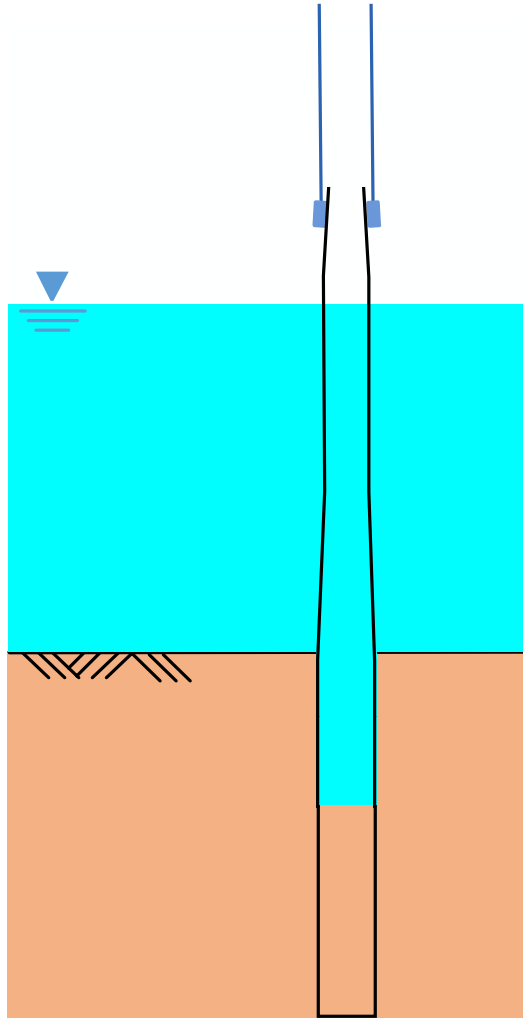
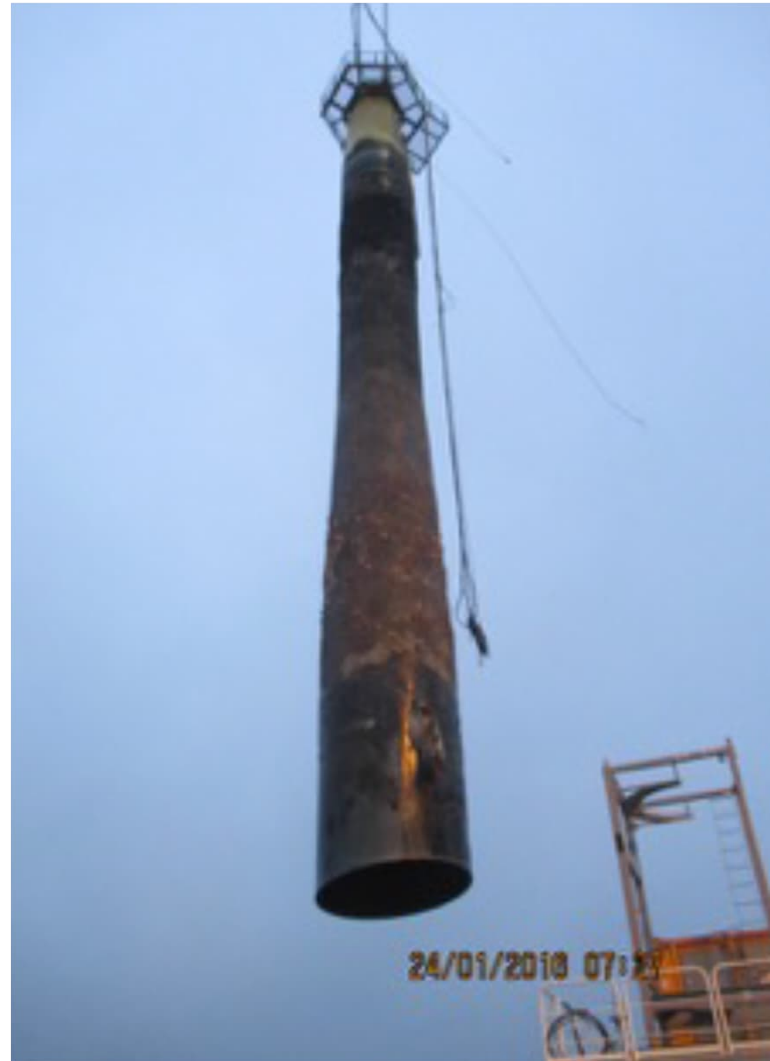
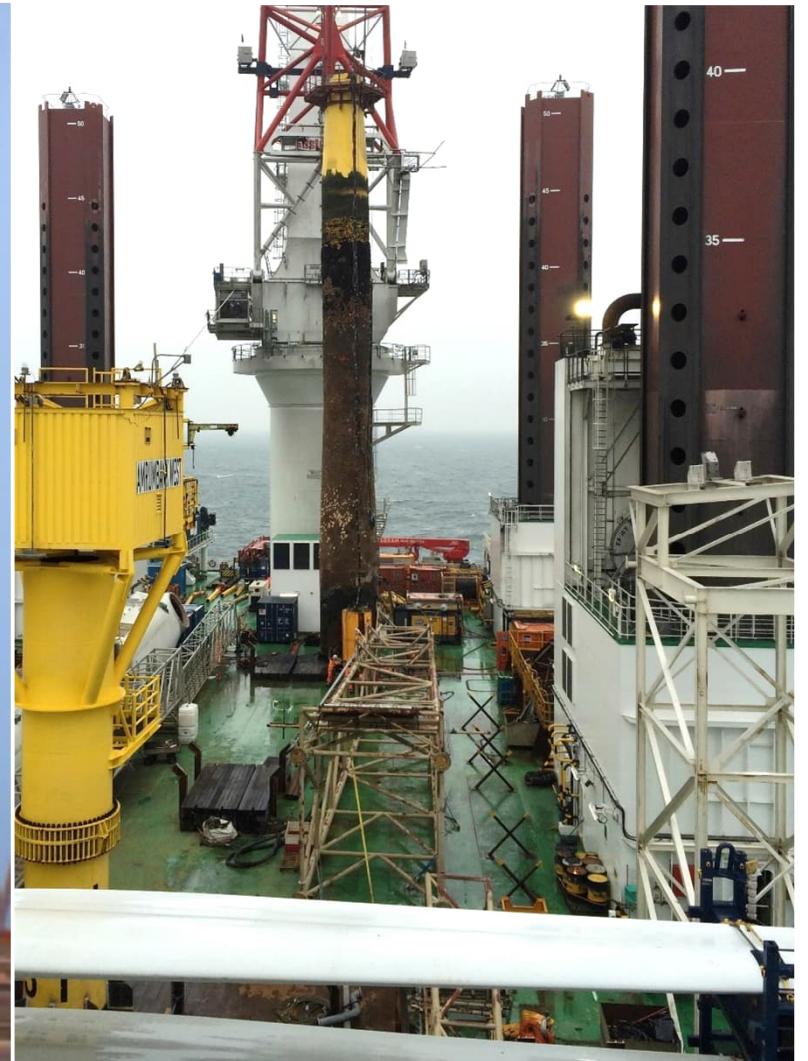
# Monopile recovery

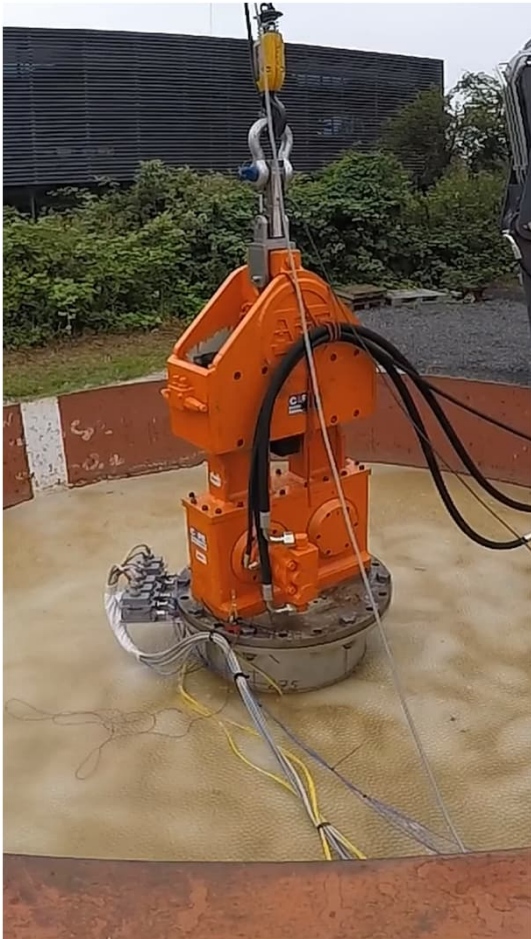
I. vibration

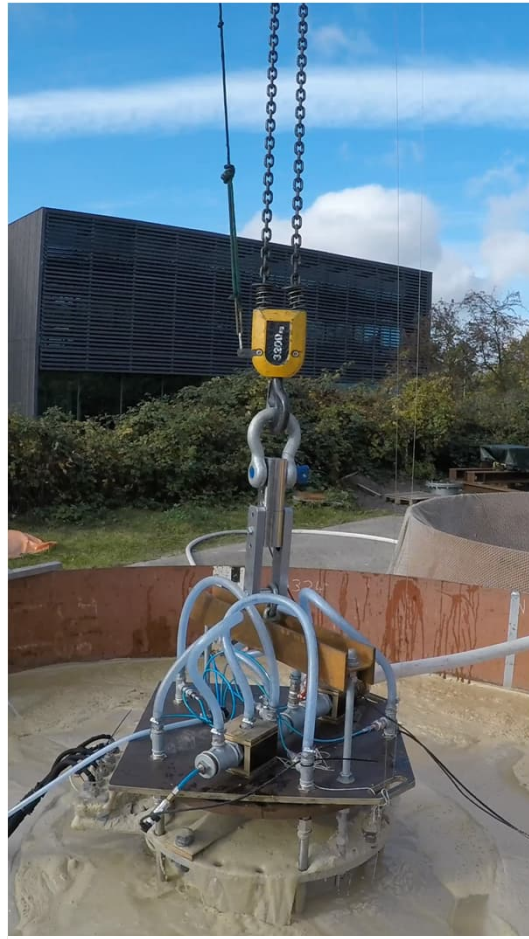
II. jetting

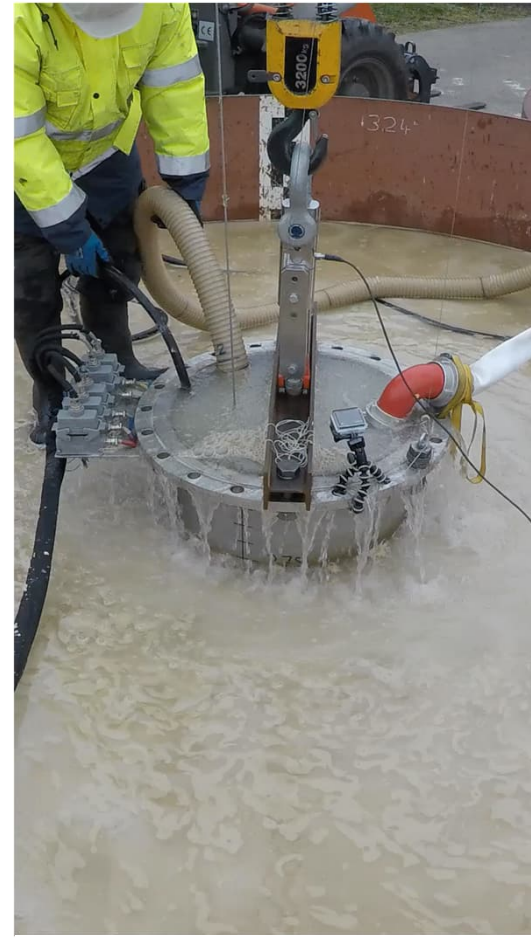
III. dredging

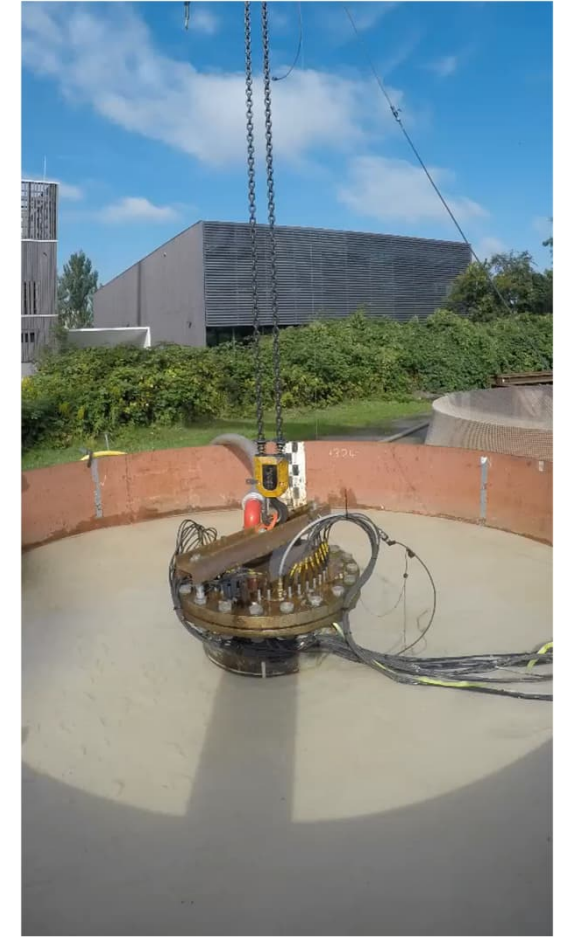
IV. hydraulic overpressure

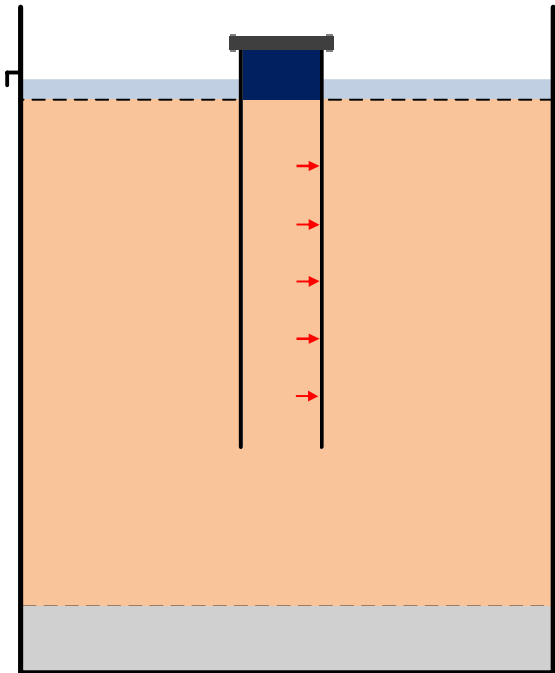
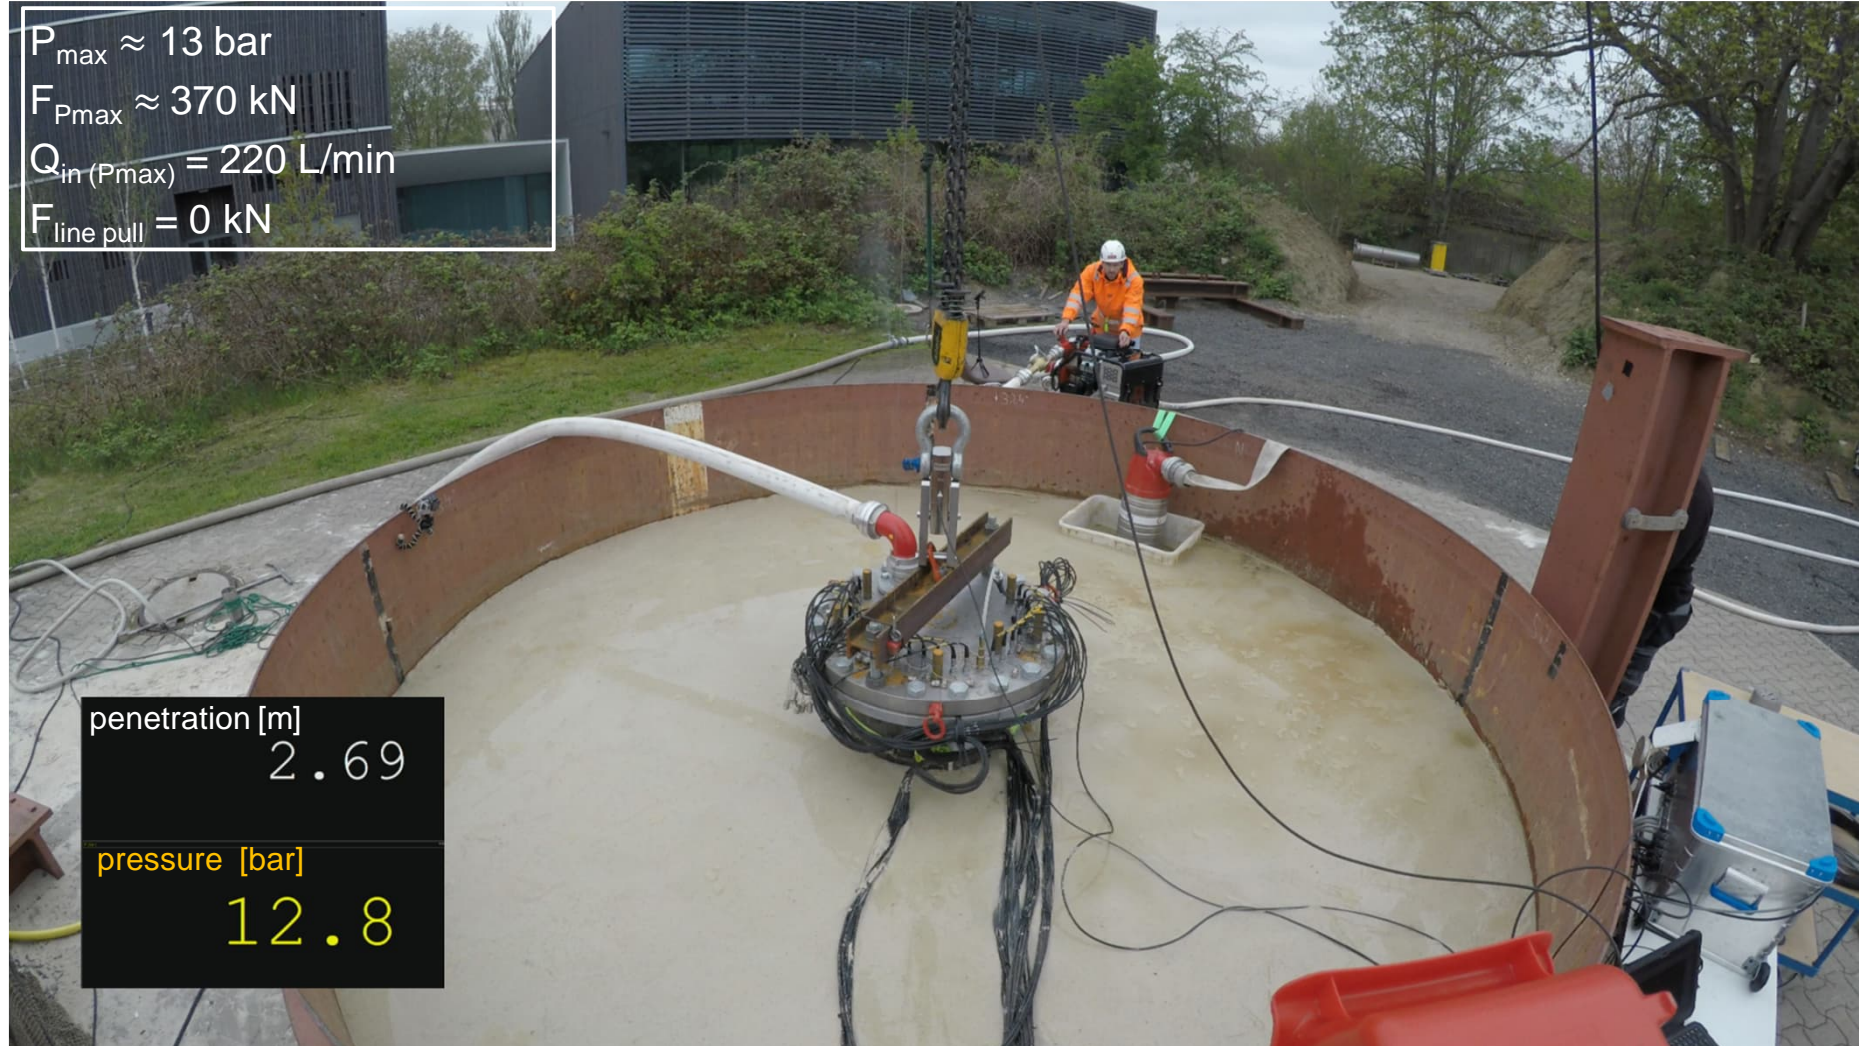
$$R_{S,STT} = 107 \text{ kN} \sim F_{Pmax} = 370 \text{ kN}$$
$$R_{HO} > R_{S,STT} !!$$

$P_{max} \approx 13 \text{ bar}$   
 $F_{Pmax} \approx 370 \text{ kN}$   
 $Q_{in(Pmax)} = 220 \text{ L/min}$   
 $F_{line\ pull} = 0 \text{ kN}$

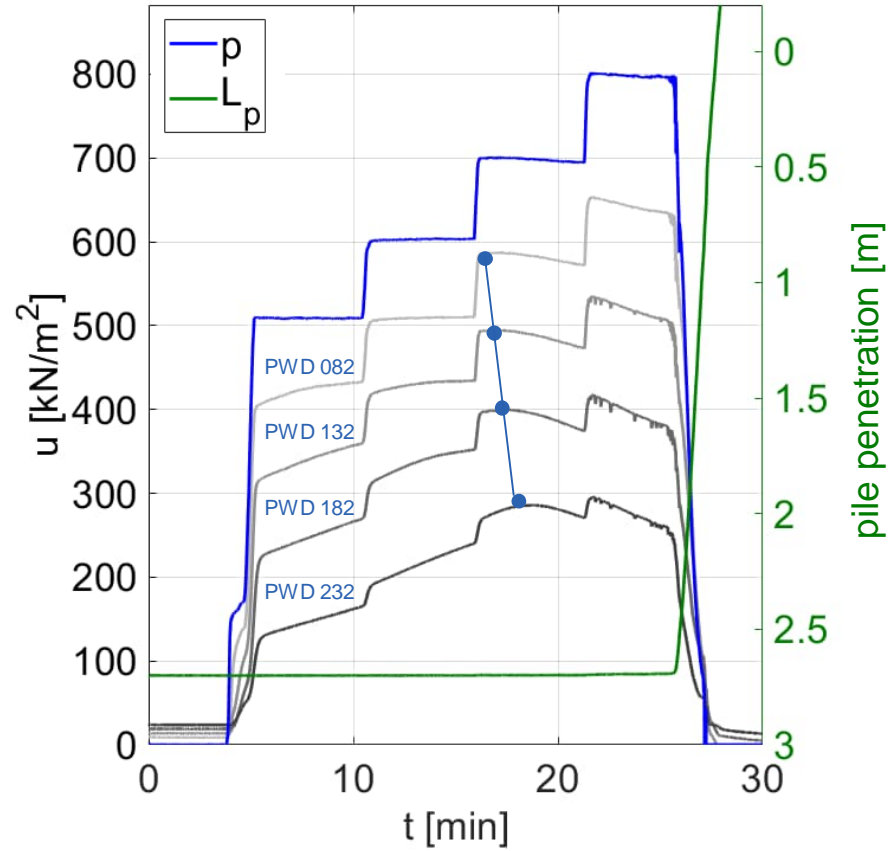
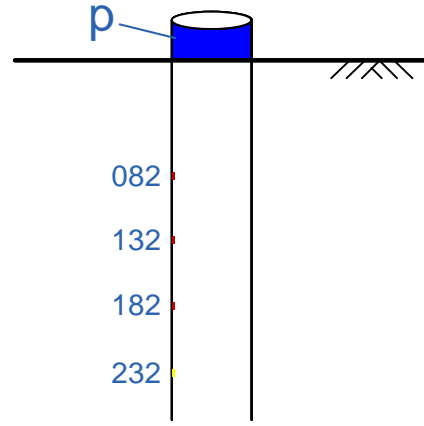
### HO2 PWD

# Testserie no. 1: HO2 – stress development

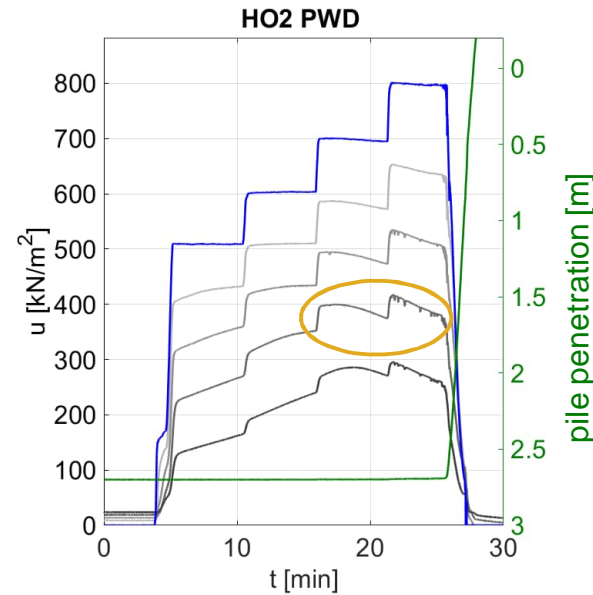
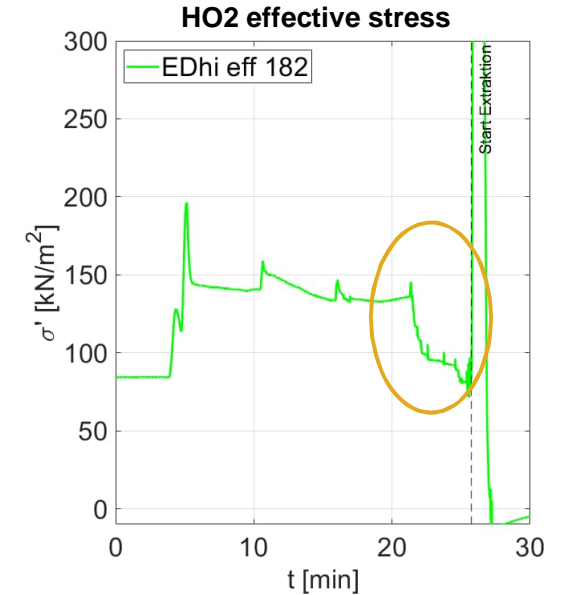
- Hydrodynamic soil deformation with grain rearrangement
  - Decrease  $PWD_i$
  - Decrease  $\sigma'_{eff(h),i}$
  - High time dependency
  - Effect on total resistance

series	loading duration	pressure load	up lift	load increase	soil
1	5 min/ stage	800 [kN/m <sup>2</sup> ]	230 [kN]	in stages	undisturbed
2	1 min	1320 [kN/m <sup>2</sup> ]	380 [kN]	linear	undisturbed
3	10 min	2000 [kN/m <sup>2</sup> ]	565 [kN]	linear	disturbed
4	/	/	107 [kN]	STT	/

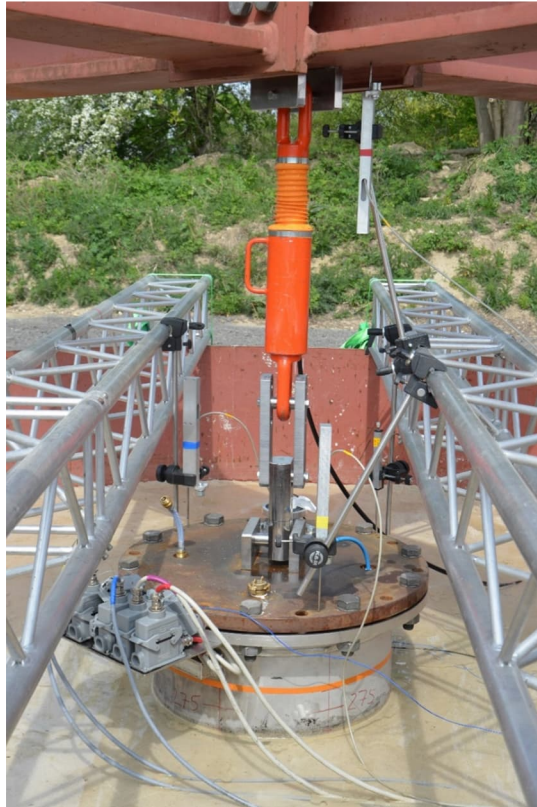
STT  
 $R_s = 107 \text{ kN}$

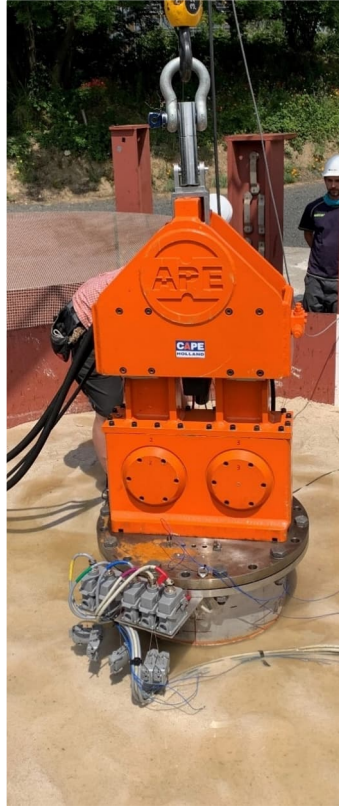
Vibro  
- 92 % ✓

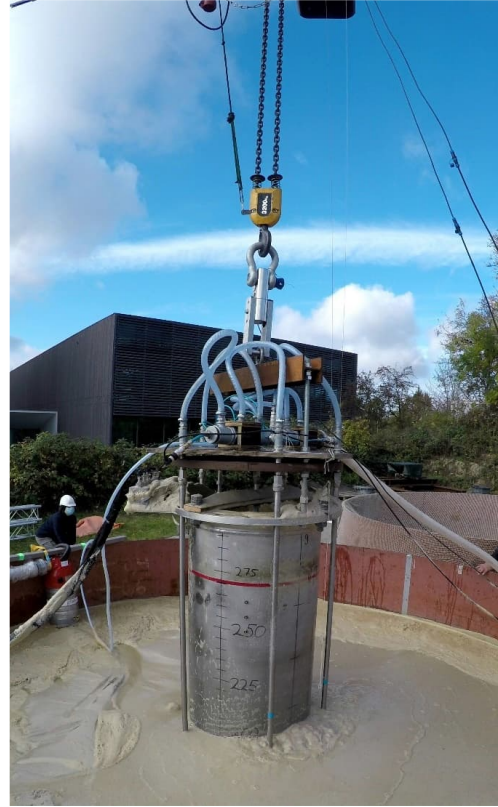
JET  
- 96 % ✓

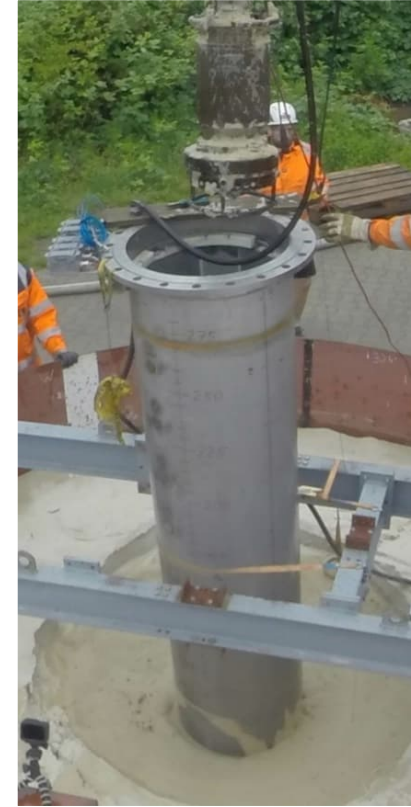
Dred  
- 74 % ✓

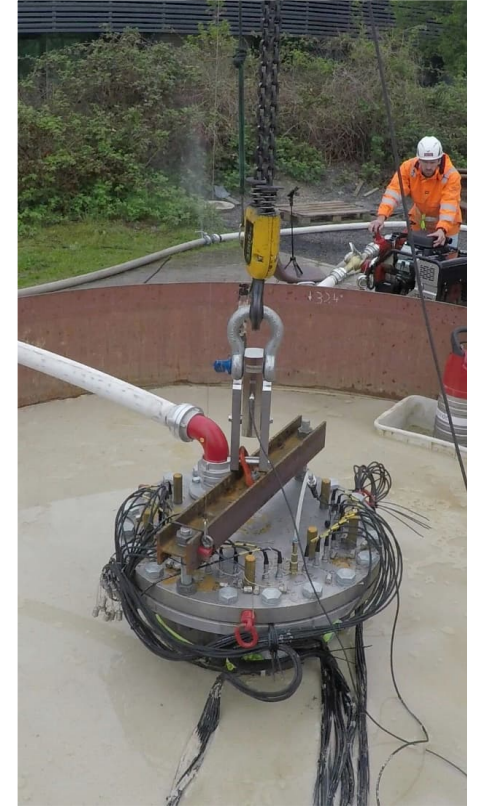
HOP  
 $P_{\text{max\_fast}} \approx 13 \text{ bar (370 kN)}$   
+ 195 % ✓  
 $P_{\text{max\_slow}} \approx 8 \text{ bar (220 kN)}$   
+ 80 % ✓
